ANNUAL ROADWAY REPORT: HOWARD AVENUE/43RD STREET RECONSTRUCTION

2014

2014 RECONSTRUCTION PROJECT REPORT

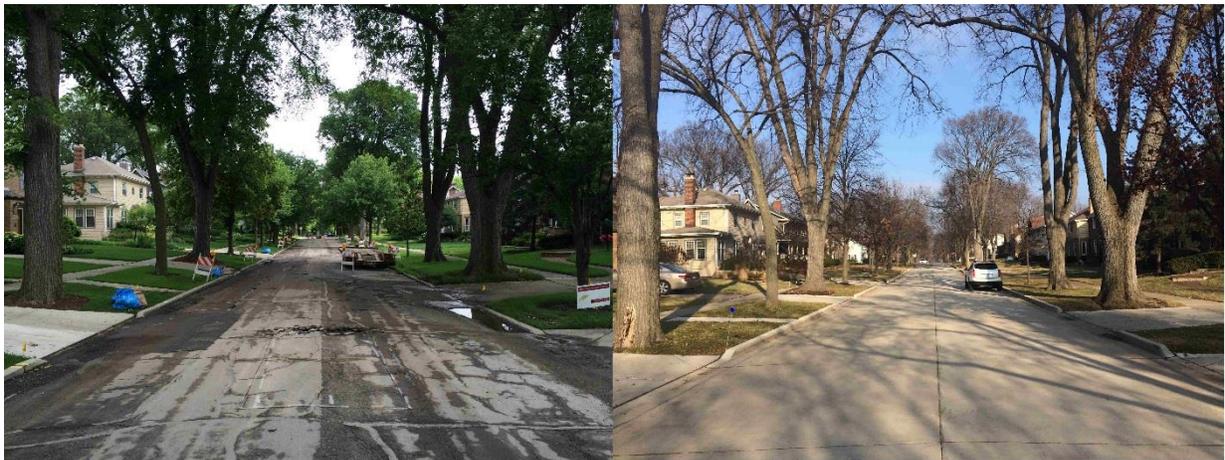
The table below shows the change in PCI ratings over the past 3 years for the roadways that were reconstructed this year. The southern segment of Howard Avenue was showing sign of failure and was in the process of being scheduled for a possible resurfacing. 43rd Street and the north segment of Howard Avenue showed increased signs of failure in a short period of time. The increased PCI ratings for these segments pushed Howard Avenue to the front of the construction schedule.

Howard Avenue before construction began (left) and Howard Avenue once the project was completed (right)

The previous pavement on Howard Avenue and on 43rd Street was asphalt. The new concrete streets are comprised of two, 12 foot lanes. New curb and gutter was poured as well to improve drainage and protect the parkway. New driveway aprons were included in the project as they were required to be removed in order to reconstruct the roadway. The new concrete pavement will ensure that minimal maintenance is needed on Howard Avenue and on 43rd Street for many years.

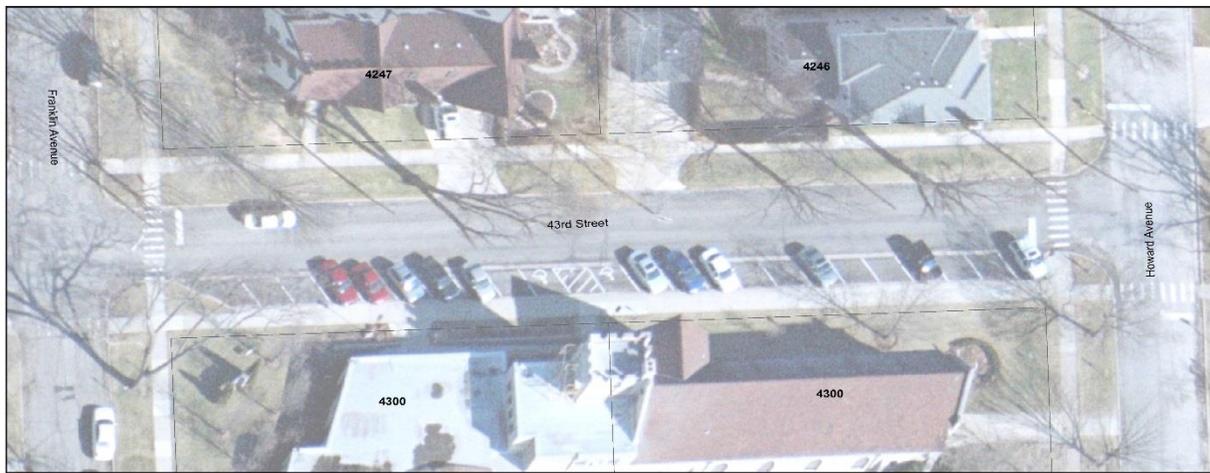
The diagonal parking stalls on the south side of 43rd Street reside within the Village right-of-way. These parking stalls are owned and maintained by the Village of Western Springs but mainly utilized by the First United Methodist Church, Field Park School, and residents of the surrounding area. The stalls were a constant nuisance to the area as they were not as deep as standard parking spaces. This caused vehicles to stick out onto 43rd Street and constrict the roadway during high volume hours of the day. The previous parking stalls can be seen in the aerial photo below. These parking stalls were a major reason for including 43rd Street into this reconstruction project.

To remedy this issue, the Village decided to move the existing sidewalk on the south side of 43rd Street farther back in order to deepen the parking spaces to the standard 17 feet. The Village and the 1st United Methodist Church decided upon an easement agreement that allowed the installation of part of the sidewalk on the Church property. This agreement also included the relocation of three light fixtures on the west side of the building. The new parking spaces now meet Village Code standards and no longer effect traffic during the peak hours of the day.

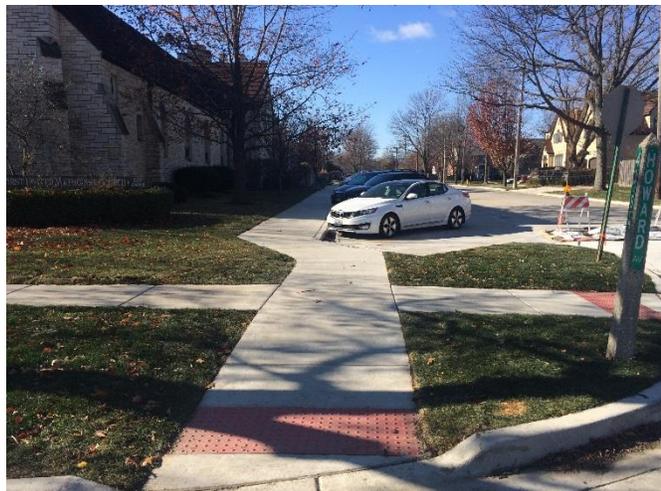
This picture depicts the change from the old configuration to the new configuration. The old sidewalk configuration started at the curb line see at the bottom of the photo and traveled straight. The new configuration created a jog in the sidewalk.

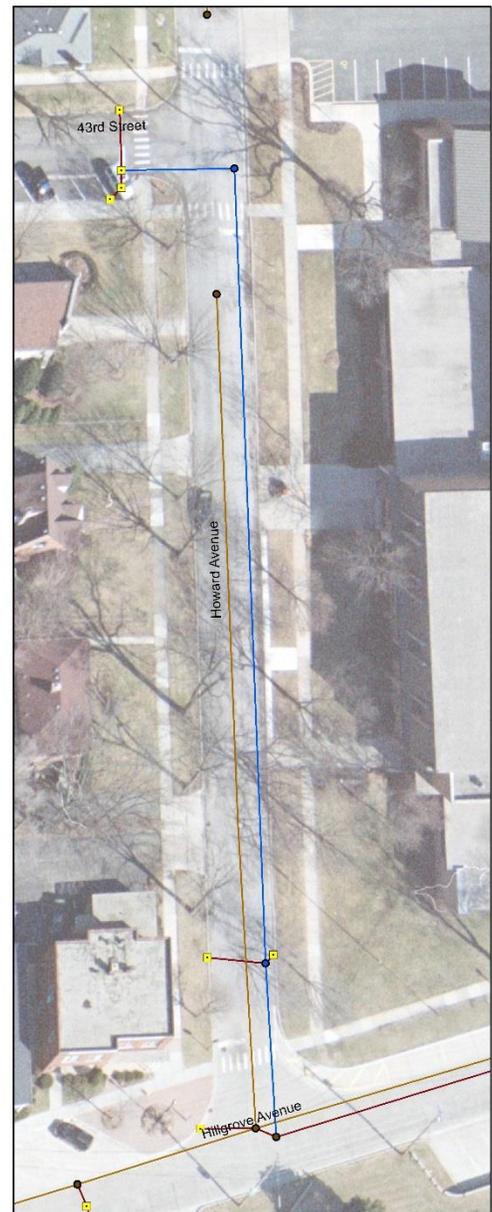
A major portion of the project involved the installation of a relief sewer on Howard Avenue. Howard Avenue previously consisted of the combined sewer that can be seen in the center of the street in the picture to the right (brown). It is first important to understand the difference between combined sewer systems and separated sewer systems. Combined sewers consist of one pipe under the roadway that takes in grey water, which is sanitary water from homes, as well as storm water runoff. Separated sewer systems consists of two pipes under the roadway, one for sanitary water and one for storm water. Western Springs is comprised of both combined and separated sewer systems. Everything north of 47th Street is a combined sewer system and everything south of 47th is a separated sewer system.

This particular relief sewer was installed to provide relief for the combined sewer system in this area of the Field Park subdivision. The new 12" relief sewer can be seen on the map to the right (blue). The majority of the pipe is reinforced concrete pipe (RCP) with the exception being 70' of pipe from the Howard Avenue manhole to the first manhole on Howard. This pipe was installed as water main quality PVC in order to maneuver around Nicor gas mains on Hillgrove and on Howard. This sewer is responsible for draining 43rd Street as well as Howard, south of 43rd. A small length of relief sewer was installed on the northern block of Howard Avenue as well. This was done to separate the mid-block inlets from the combined sewer system. The Northern block of Howard Avenue was known to flood during storm events previous to the reconstruction. This has not occurred since the project was completed.

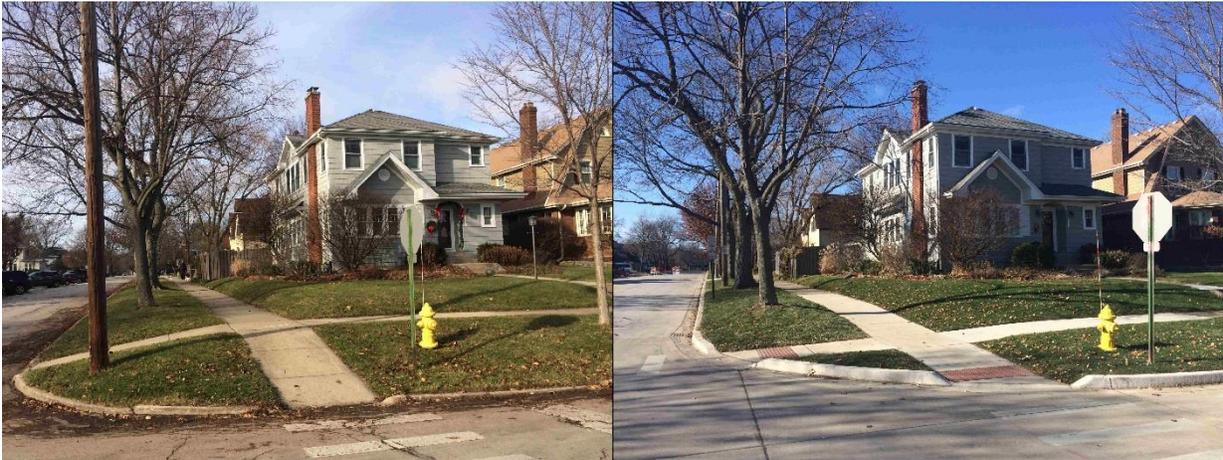
In the case of this project, the intersection of 43rd Street and Howard Avenue had severe ADA compliance issues prior to reconstruction. With proximity to the First United Methodist Church and the Field Park School, this was another important factor for including 43rd Street into the project.

The picture shows the before (left) and after (right) of the northwest corner of 43rd Street and Howard Avenue. All other intersections involved in this project were reconstructed to be ADA compliant as well.

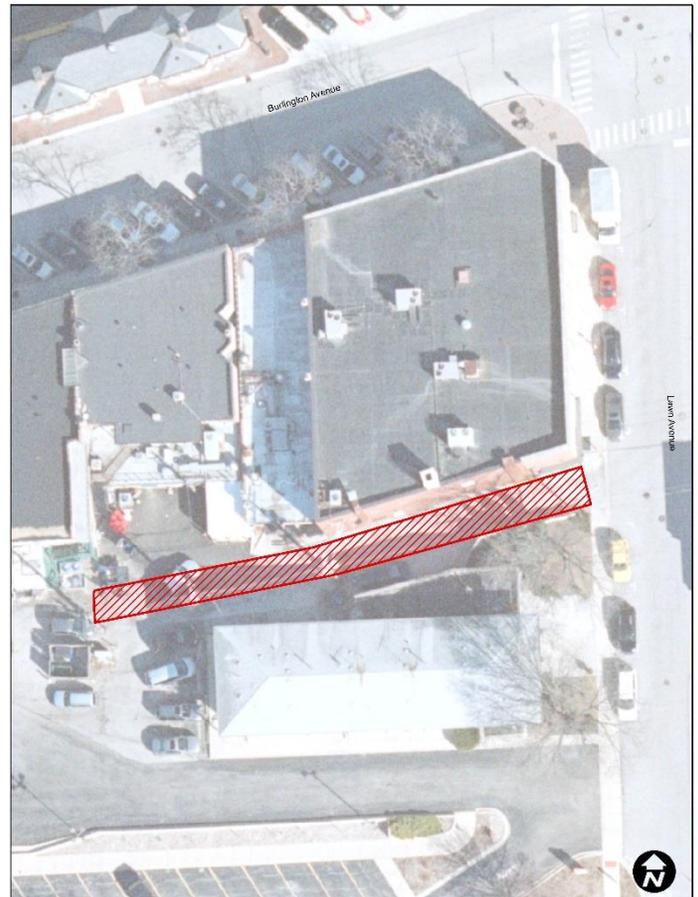
The previous alleyway was comprised of asphalt pavement in very poor condition. This was mainly due to a large volume of delivery and garbage trucks for the downtown businesses. In addition, there was known flooding problems directly behind Casey’s Market.

The only incident that occurred during this project was the damage to the Casey’s Market gas service. The gas service was hit by the contractor on the morning of September 2nd and was not repaired by Nicor until the evening.

The project included the full concrete reconstruction of the area outlined. There was also 72.2 FT of 6” storm sewer installed in order to improve drainage issues.

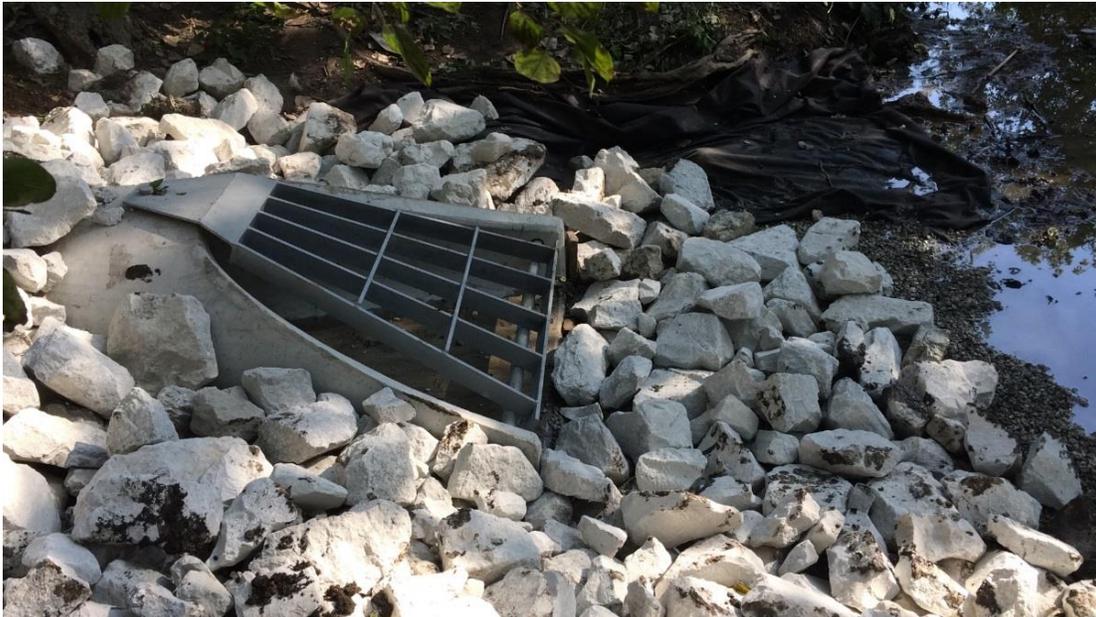
Municipal Services was alerted of a sinkhole in the rear yard of 5708 Ridgewood Drive in the fall of 2013. Upon further inspection, it was determined that the sinkhole was created due to a section of deteriorated corrugated metal storm sewer that terminated at Flagg Creek. This particular pipe is known as an outfall and provides an exit into Flagg Creek for storm water. The pipe was televised and it was determined that the system was still fully functional, but would require repair to prevent future issues.

The repair took place on September 18th. The project included the installation of 45 FT of reinforced concrete pipe (RCP) and a flared end structure at the outfall (see photo above). The project required crews to move heavy equipment between the homes at 5704 Ridgewood Drive and 5708 Ridgewood Drive. The project was completed with no outstanding issues and the area was restored to its previous condition with new sod.
