JAMES J. BENES AND ASSOCIATES, INC.

MEMORANDUM

Re: Project No. 690.169
5400 block Franklin
Side Yard Drainage

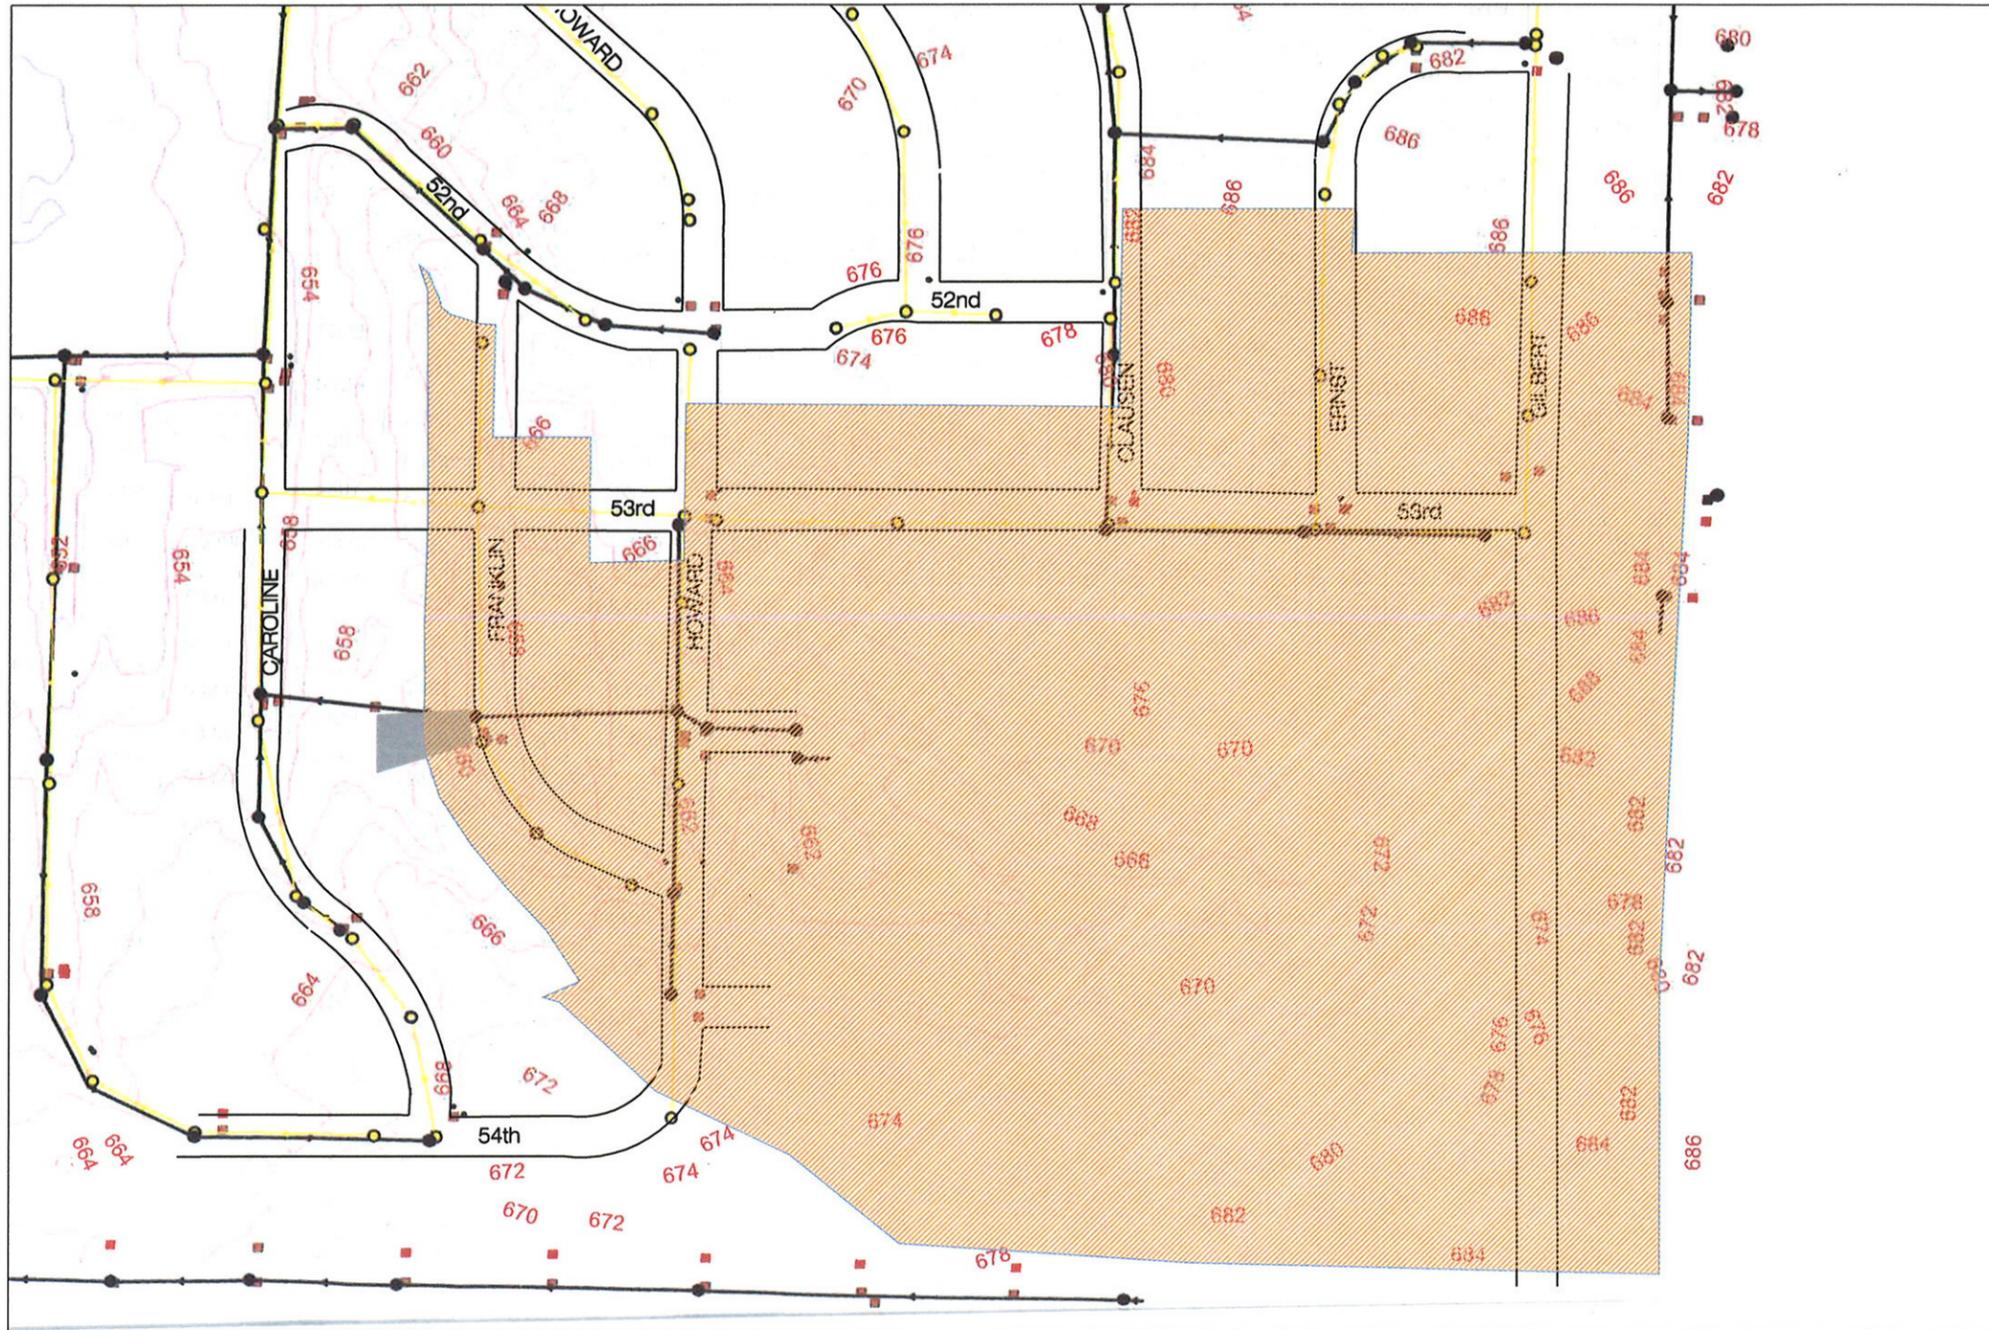
DRAINS TO 5400 FRANKLIN AVENUE

The residence at 5400 Franklin was replaced in 2005. The approved plans showed an overflow path on the south side of the building. Water runoff then drains north to the existing inlet off-lot. The south flow path was lower than the window wells by three to six inches. We re-surveyed the drainage path and discovered that over time the path has changed. The ridge line, that is, the high point to which water can pond has increased. This high point elevation is above the window wells to 5400 Franklin and its garage floor. During the August storm event, water ponded high enough to break the window wells and to enter the garage.

It is essential that an overland flow route be established around the house so water can pass at a lower elevation than today. Several properties are at risk, but 5400 is most vulnerable to ponding water. Water cannot pond higher than its tops of the window wells and garage floor. Attached is an aerial photograph locating this proposed improved overland drainage path. A profile is also attached, providing a view as if the path were sliced longitudinally. The vertical scale of the profile has been greatly exaggerated to illustrate differences in elevation. Several inches of material must be removed in some places. There are many choices in creating a new drainage path. The cross section can be rectangular or trapezoidal. Many surfaces for the path are possible. These surfaces must be resistant to the movement of water, so the use of wood mulch is strongly discouraged. Attached are examples of reinforced drainage paths from other sites.

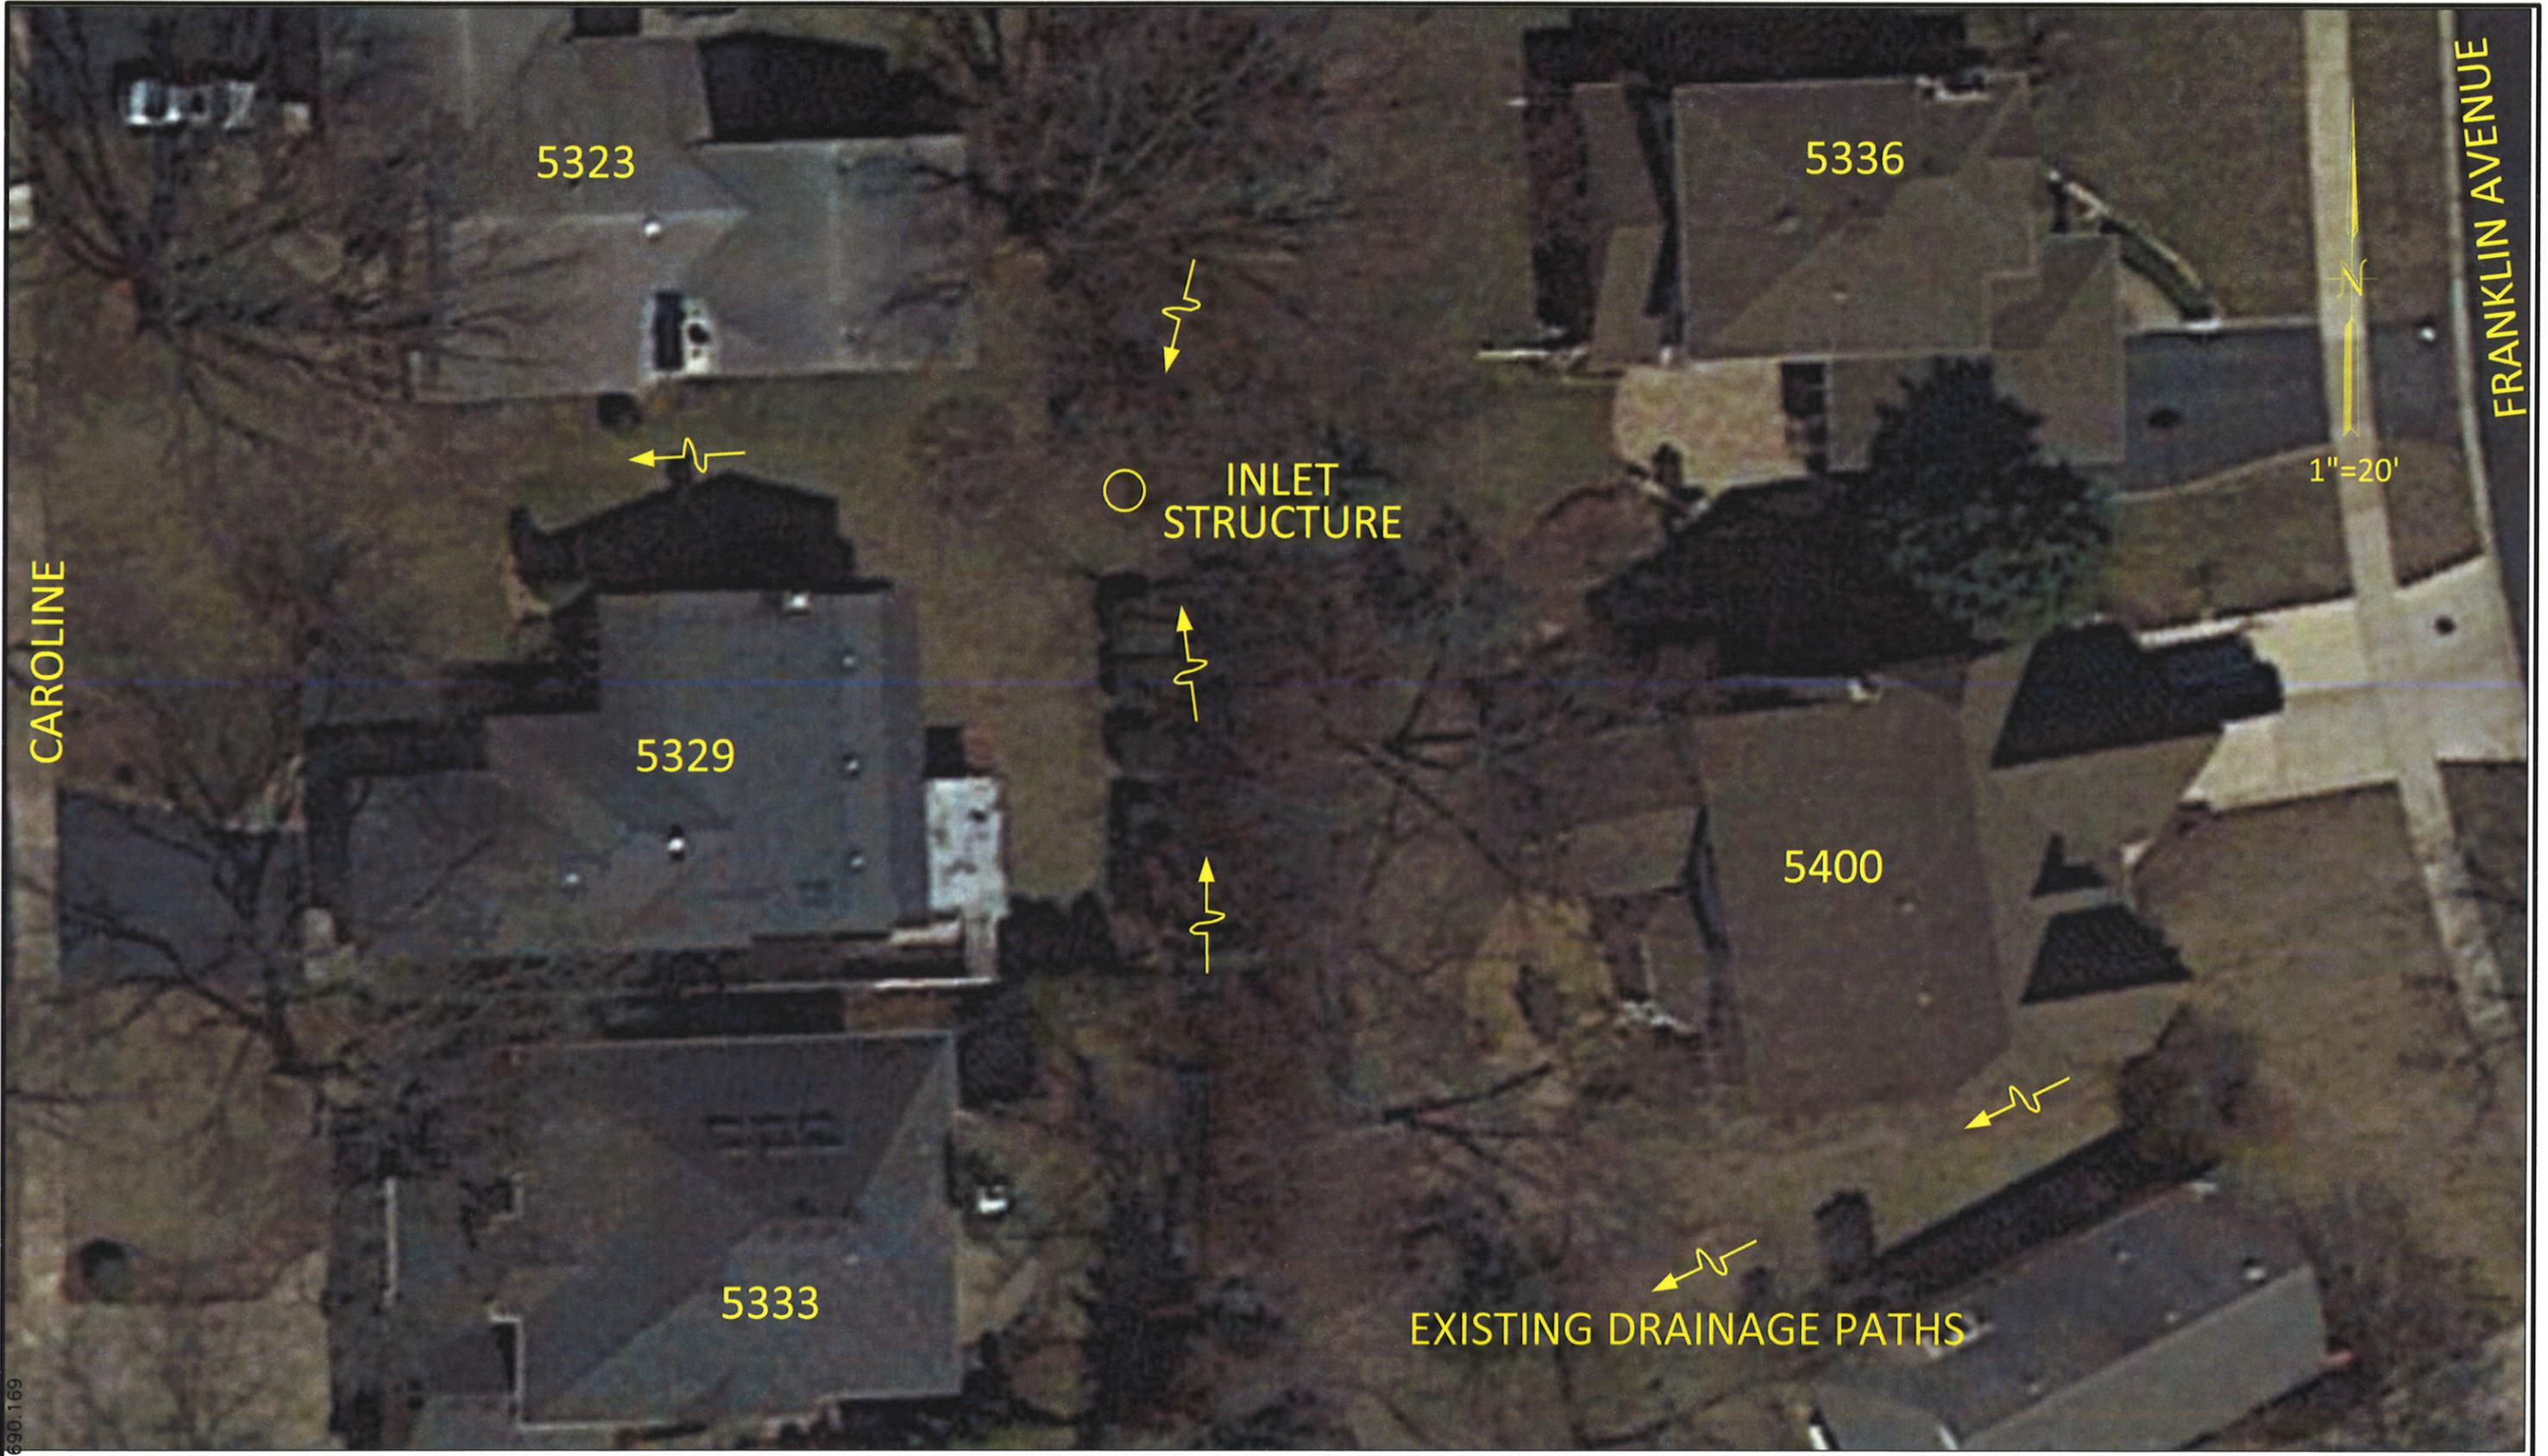
5400 FRANKLIN AVENUE

HIGH POINT BELOW GARAGE FLOOR AND WINDOW WELLS

PROPOSED IMPROVED OVERLAND FLOW ROUTE
