Ogden Avenue & Wolf Road Eastbound and Westbound Approaches

Automated Red-Light Camera Enforcement System Statistical Analysis and Evaluation

WESTERN SPRINGS POLICE DEPARTMENT

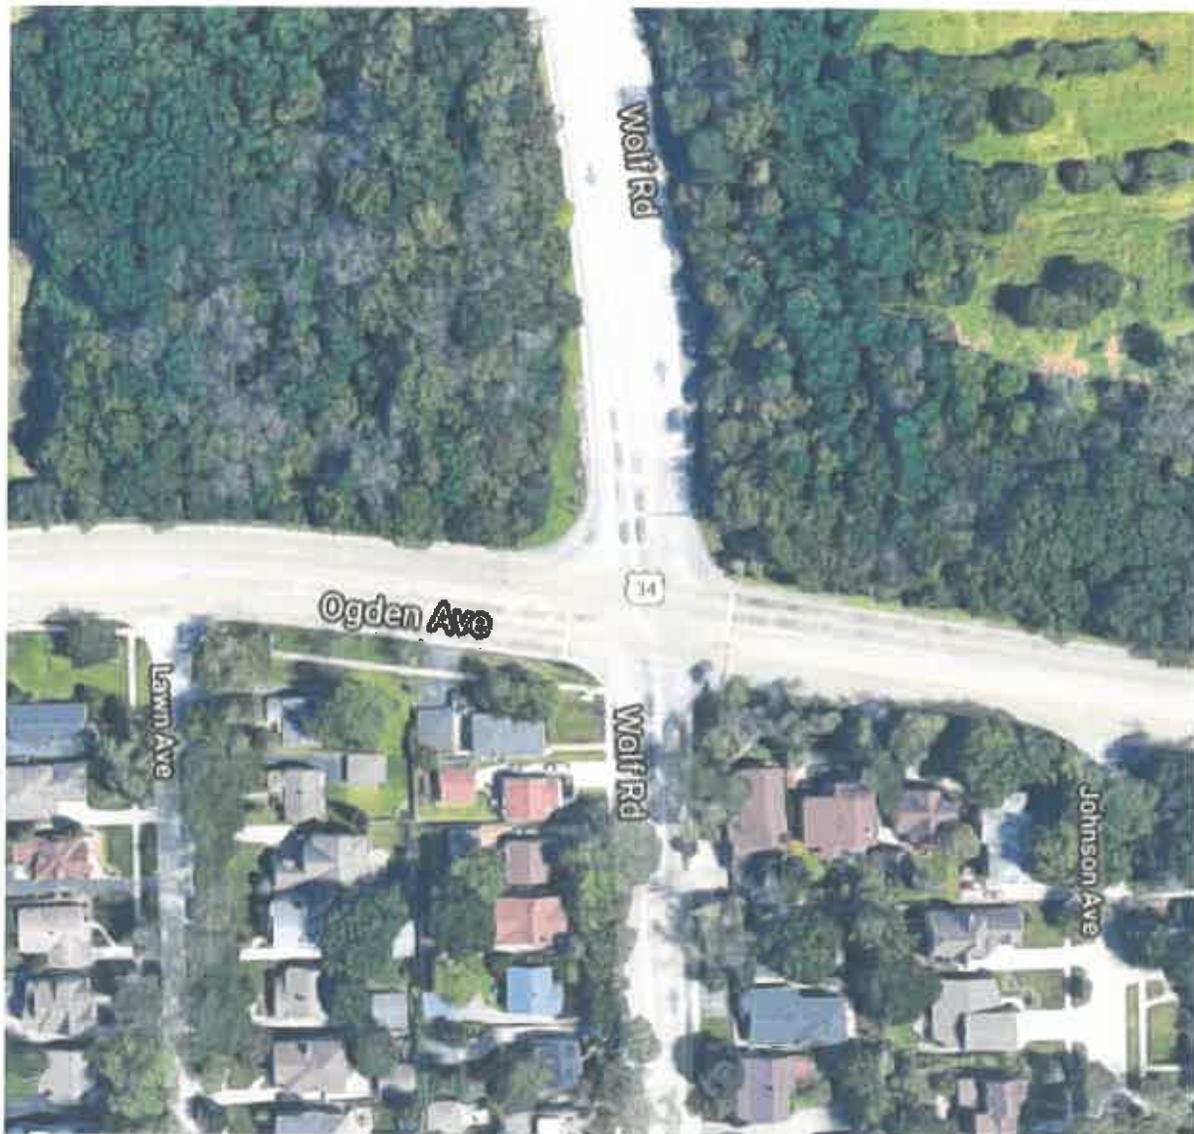
Ogden Avenue at Wolf Road
Western Springs, IL

- RLR Photo Enforcement System monitors violations occurring on the eastbound and westbound approaches of the intersection
- RLR Photo Enforcement System installed: May 24, 2009
- Traffic signal timing strictly adheres to the guidelines for timing of clearances established by the Illinois Department of Transportation (IDOT), in accordance with the MUTCD standards. Neither the Vendor nor the Village has access to or influence over the establishment of signal timings. Both entities understand that tampering with these timings would be a safety violation with significant consequences.

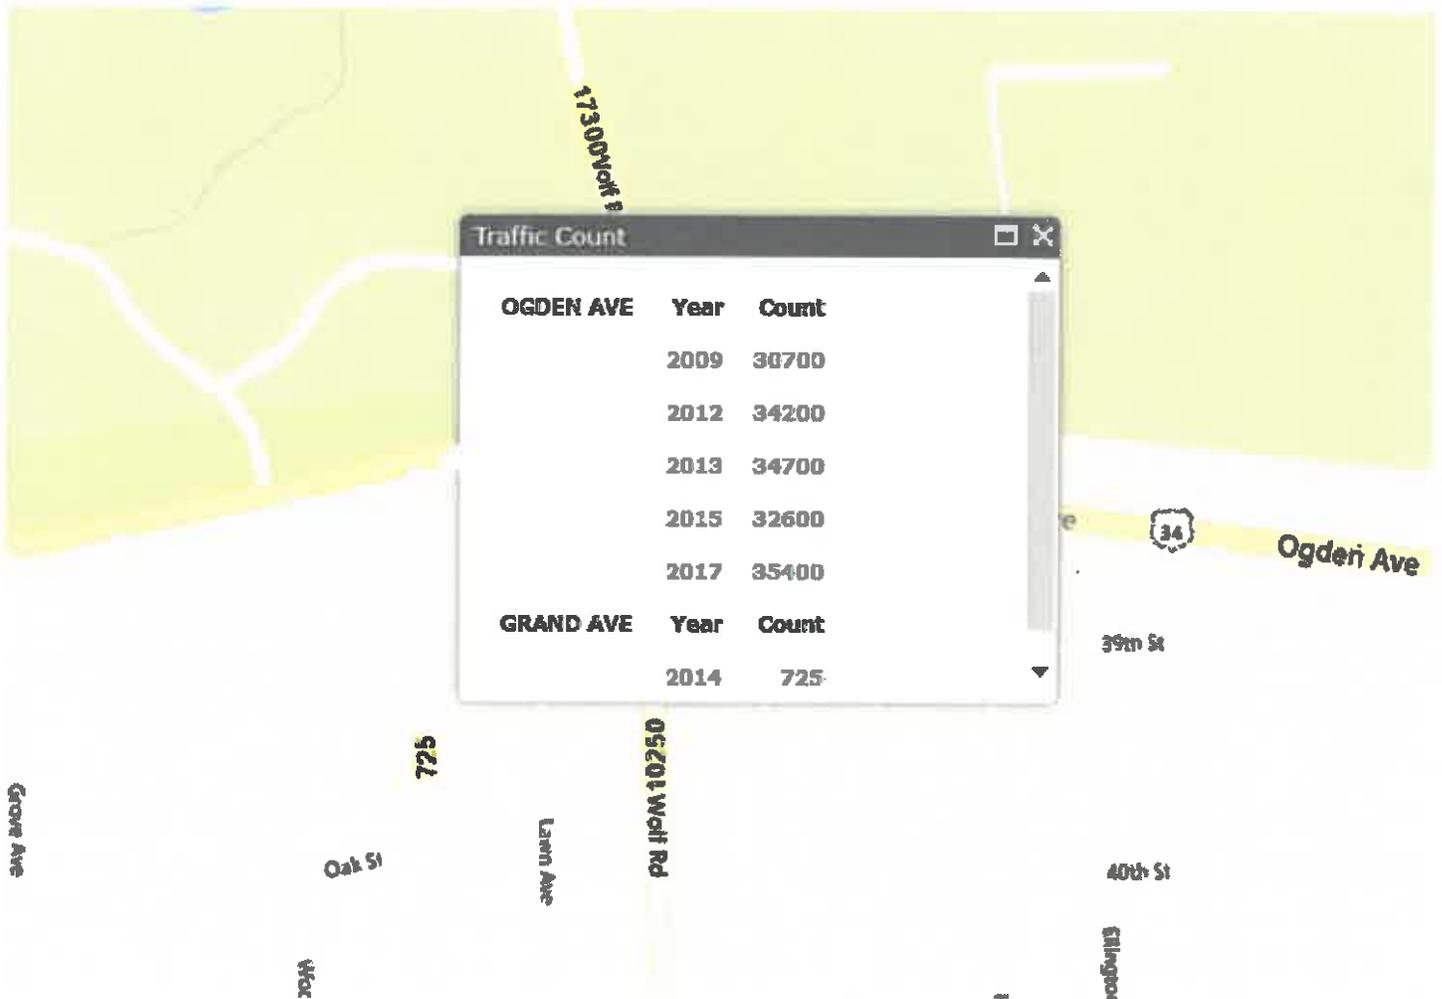
Ogden Avenue & Wolf Road (Eastbound)

Average Daily Traffic

- 30,700 (2009)
- 34,200 (2012)
- 34,700 (2013)
- 32,600 (2015)
- 35,400 (2017)

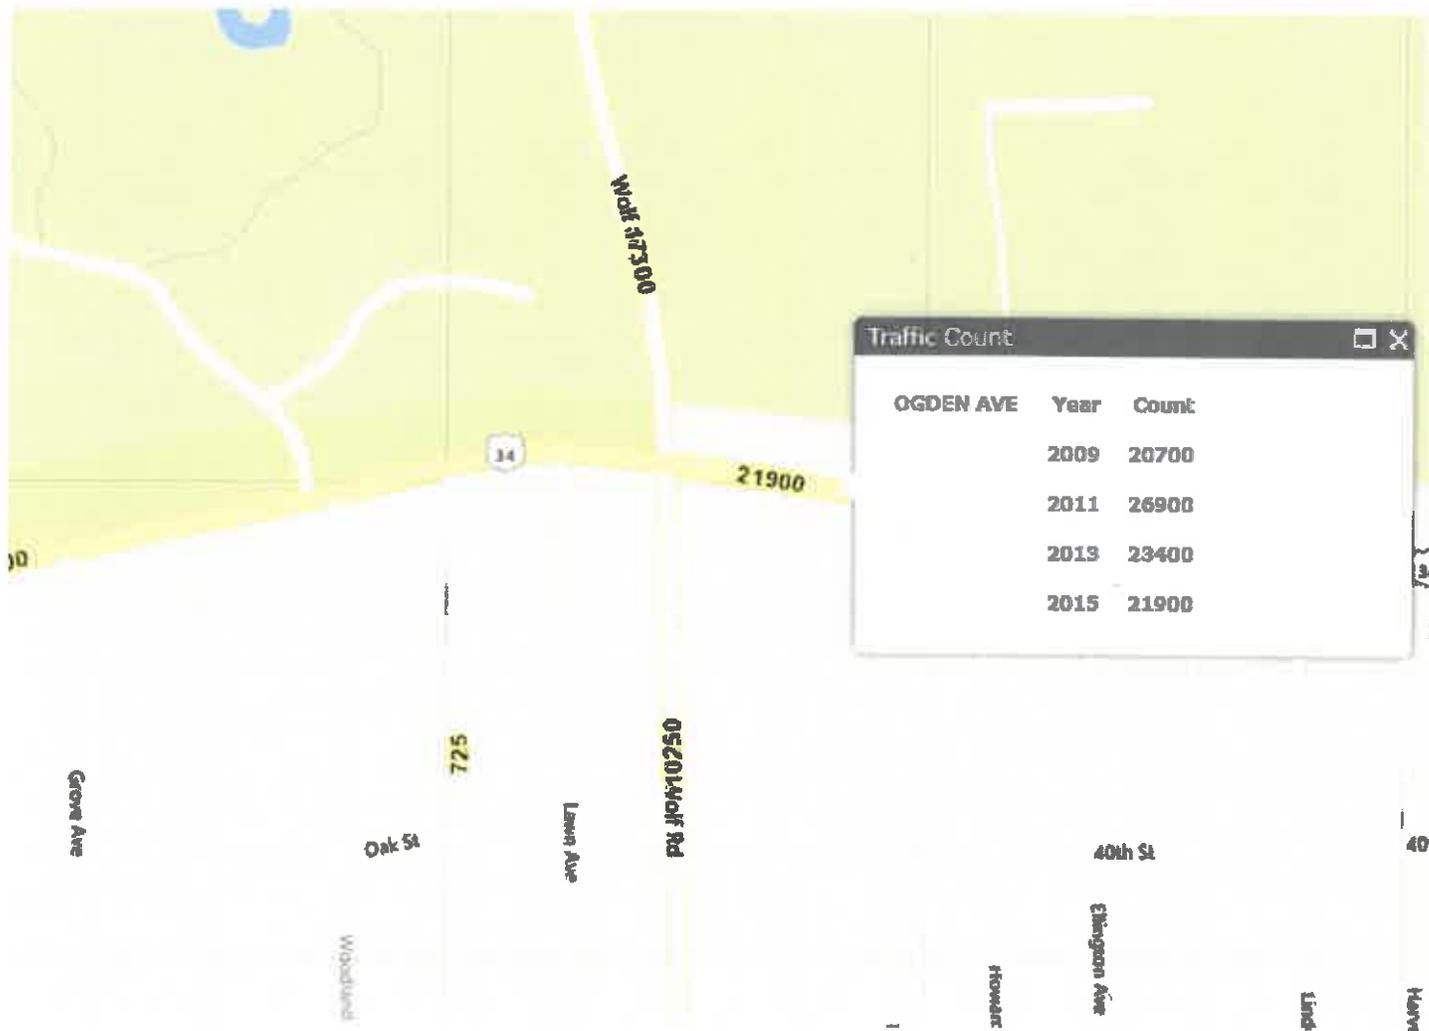
Ogden Avenue & Wolf Road (Westbound)

Average Daily Traffic (continued)

- 20,700 (2009)
- 26,900 (2011)
- 23,400 (2013)
- 21,900 (2015)

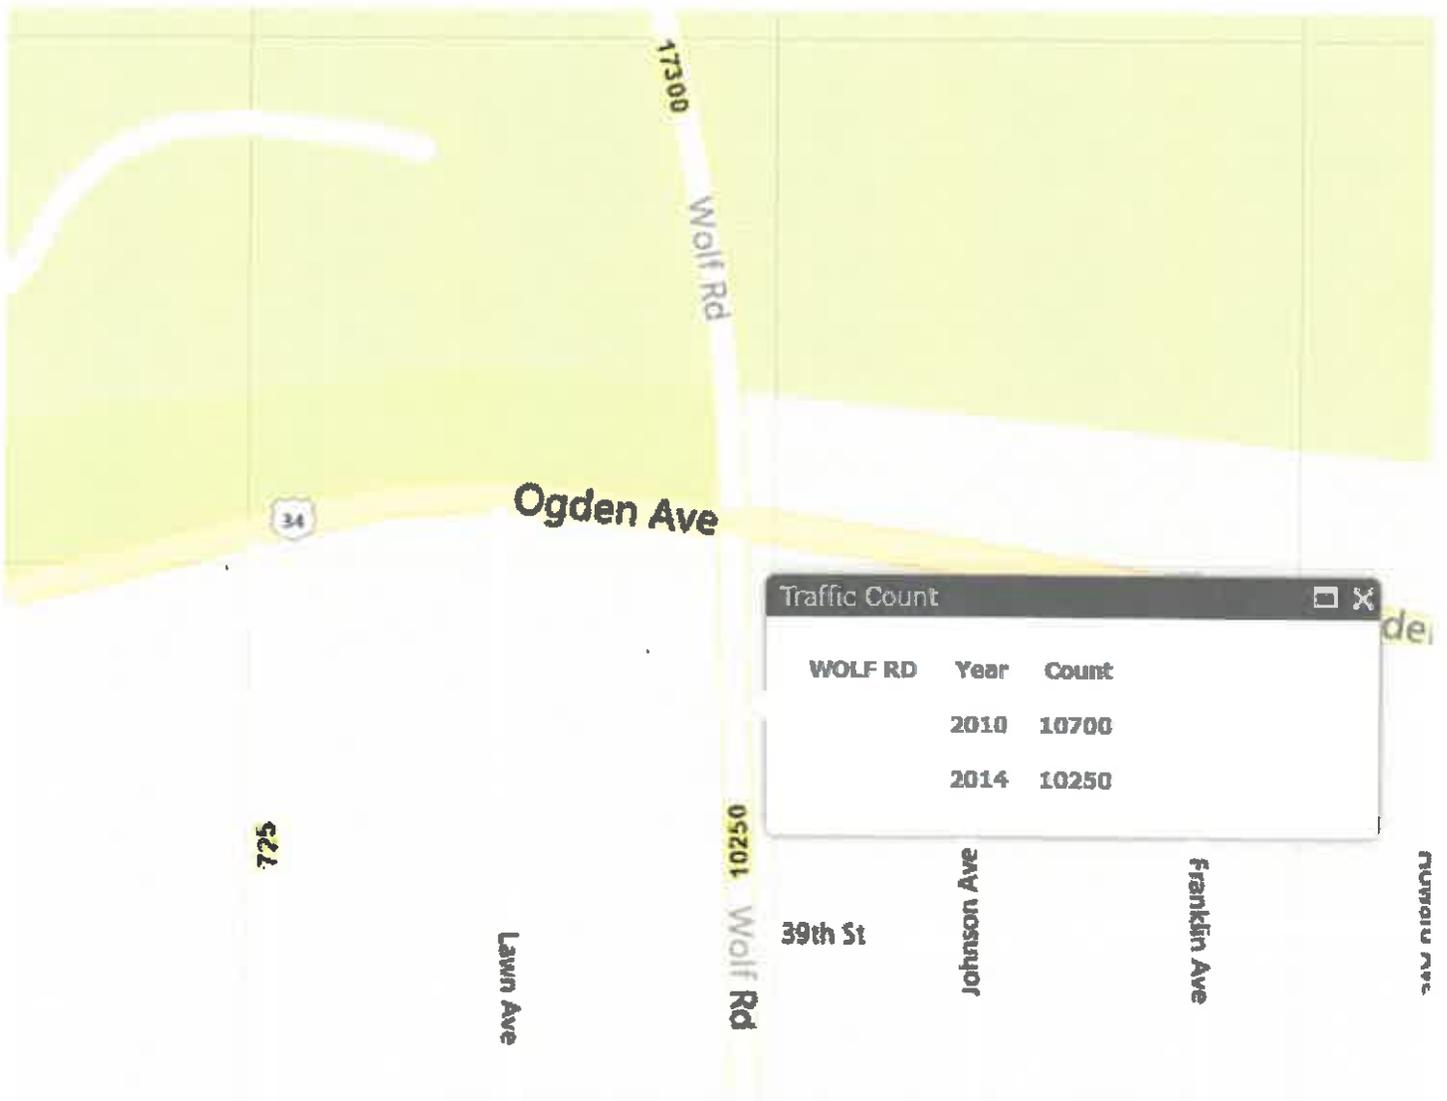
Ogden Avenue & Wolf Road (Northbound)

Average Daily Traffic (continued)

- 10,700 (2010)
- 10,250 (2014)

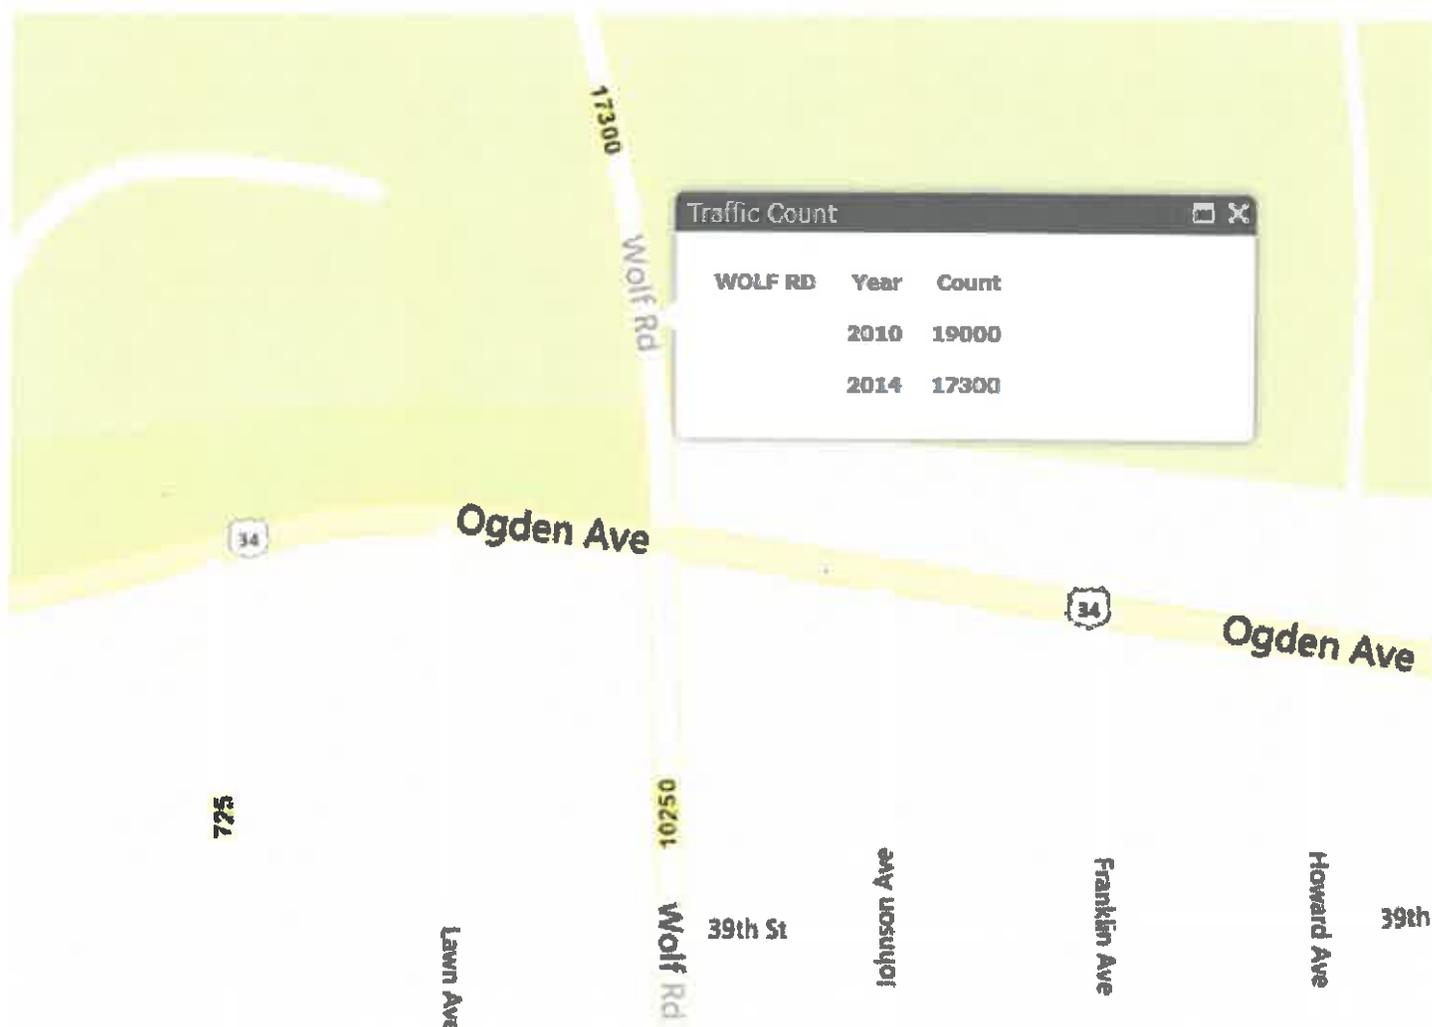
Ogden Avenue & Wolf Road (Southbound)

Average Daily Traffic (continued)

- 19,000 (2010)
- 17,300 (2014)
